By
Anatol Rabinkin,
Honeywell Int., METGLAS• Solutions

Appendix

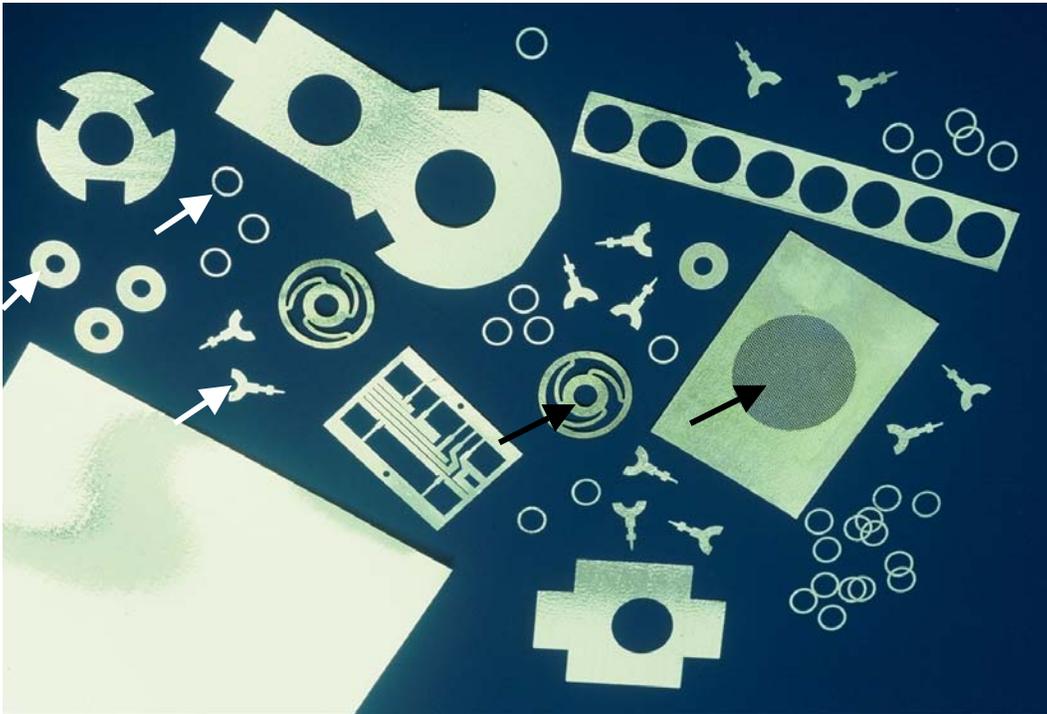
8. Various preforms from MBF ribbons stamped into intricate shapes (white arrow) and photoetched to form multiple small holes or sophisticated profiles (black arrows).

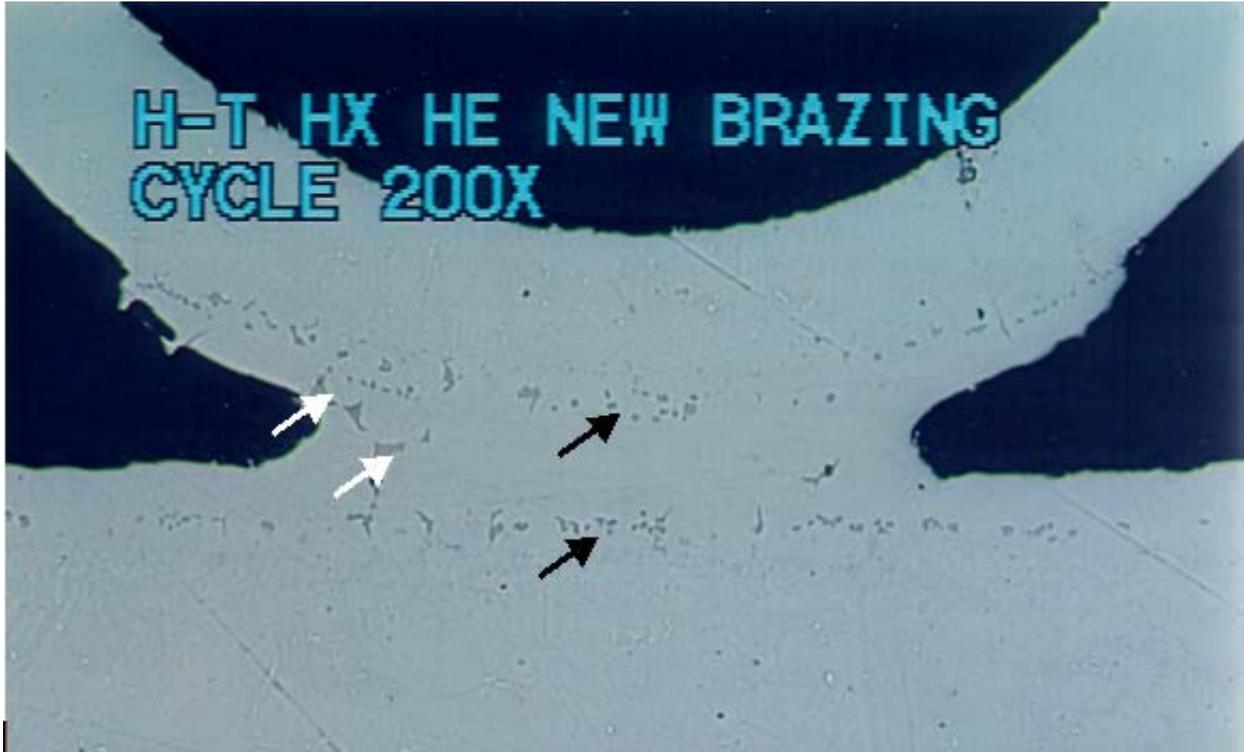
16. SEM micrograph of an IN625/MBE 51 joint after a 90-min brazing cycle at 1155°C in vacuum with slow heating and cooling stages to avoid cracking induced by thermal stresses.

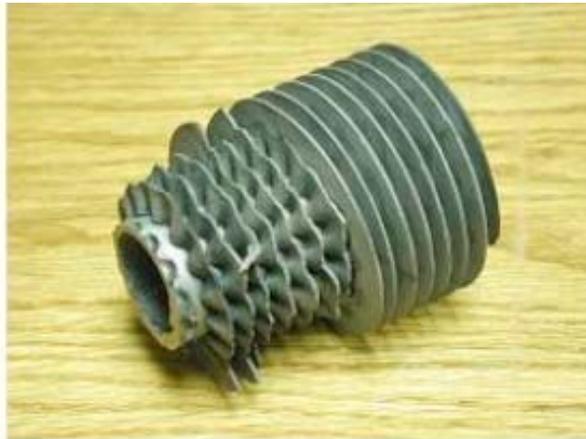
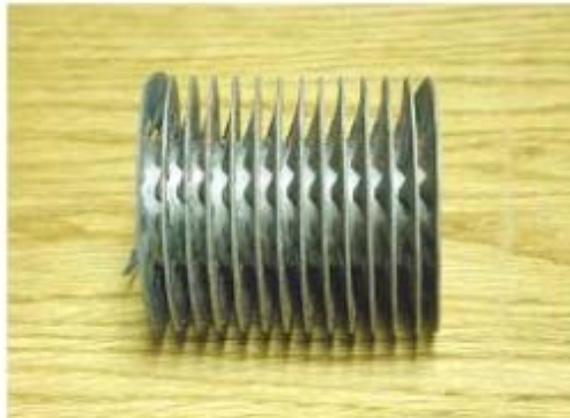
22. Two samples of SB423 tubes brazed using MBF-20 (a) and MBF-53 (b) after 1126 hours corrosion testing according to ASM G28-97 standard procedure.
